Department of Conservation and Restoration

Biodeterioration of glazed wall tiles

Mathilda L. Coutinho

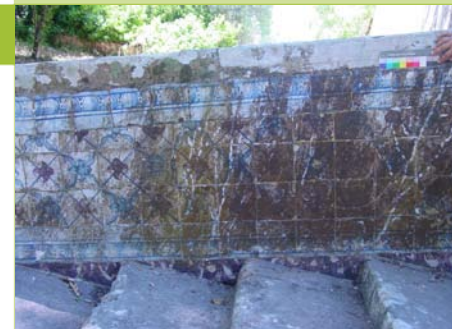
Biological colonization on Casa da Pesca (Oeiras) tiles.

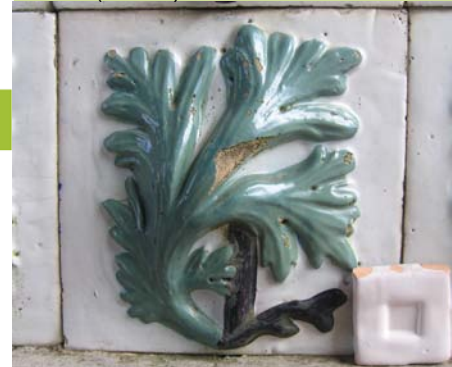
Picture of a reproduction of the white glaze in front of an original tile

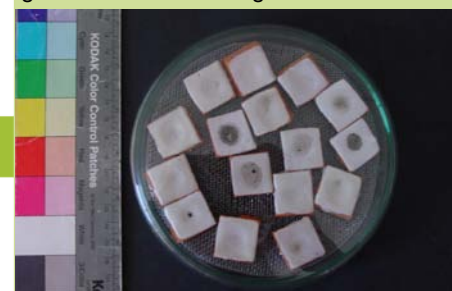
Artificial inoculation with fungi on reproduced glazes.
